GREENVILLE AVENUE (US 11) CORRIDOR IMPROVEMENT STUDY

Study Work Group Meeting #1

April 8, 2019

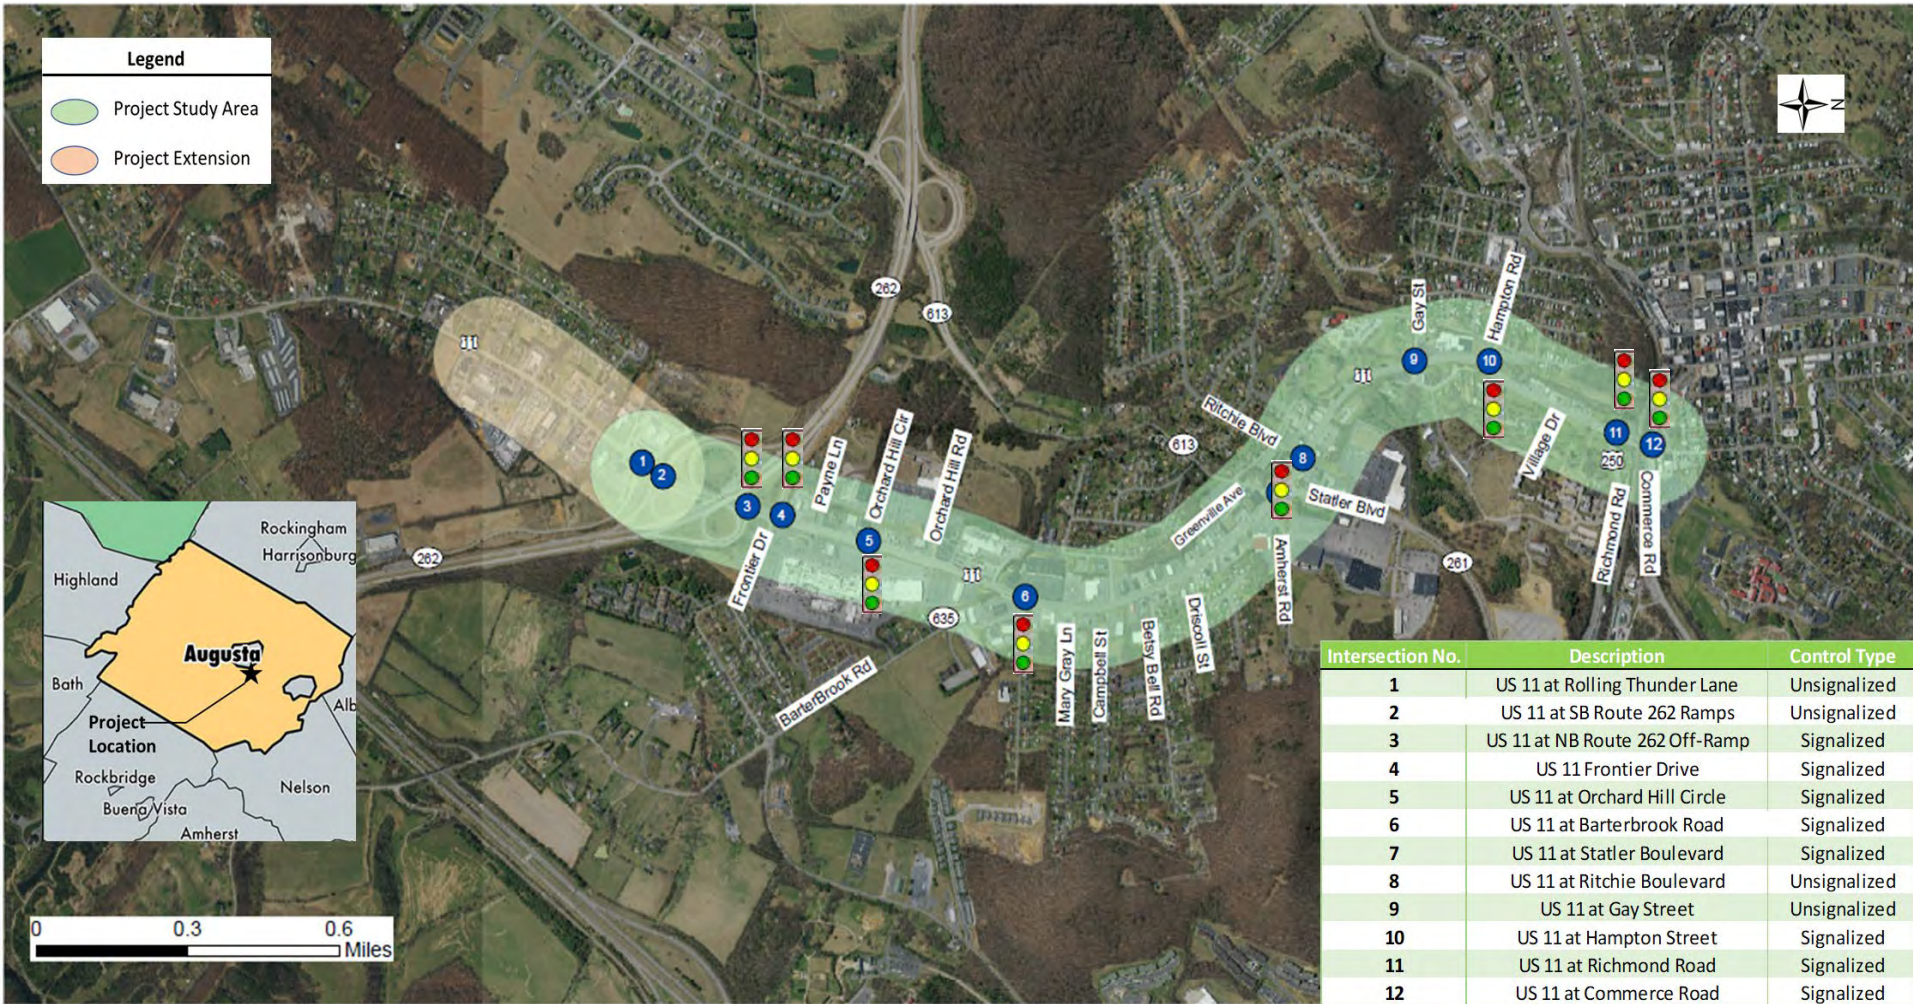
STUDY CORRIDOR

Intersection No.	Description	Control Type
1	US 11 at Rolling Thunder Lane	Unsignalized
2	US 11 at SB Route 262 Ramps	Unsignalized
3	US 11 at NB Route 262 Off-Ramp	Signalized
4	US 11 Frontier Drive	Signalized
5	US 11 at Orchard Hill Circle	Signalized
6	US 11 at Barterbrook Road	Signalized
7	US 11 at Statler Boulevard	Signalized
8	US 11 at Ritchie Boulevard	Unsignalized
9	US 11 at Gay Street	Unsignalized
10	US 11 at Hampton Street	Signalized
11	US 11 at Richmond Road	Signalized
12	US 11 at Commerce Road	Signalized

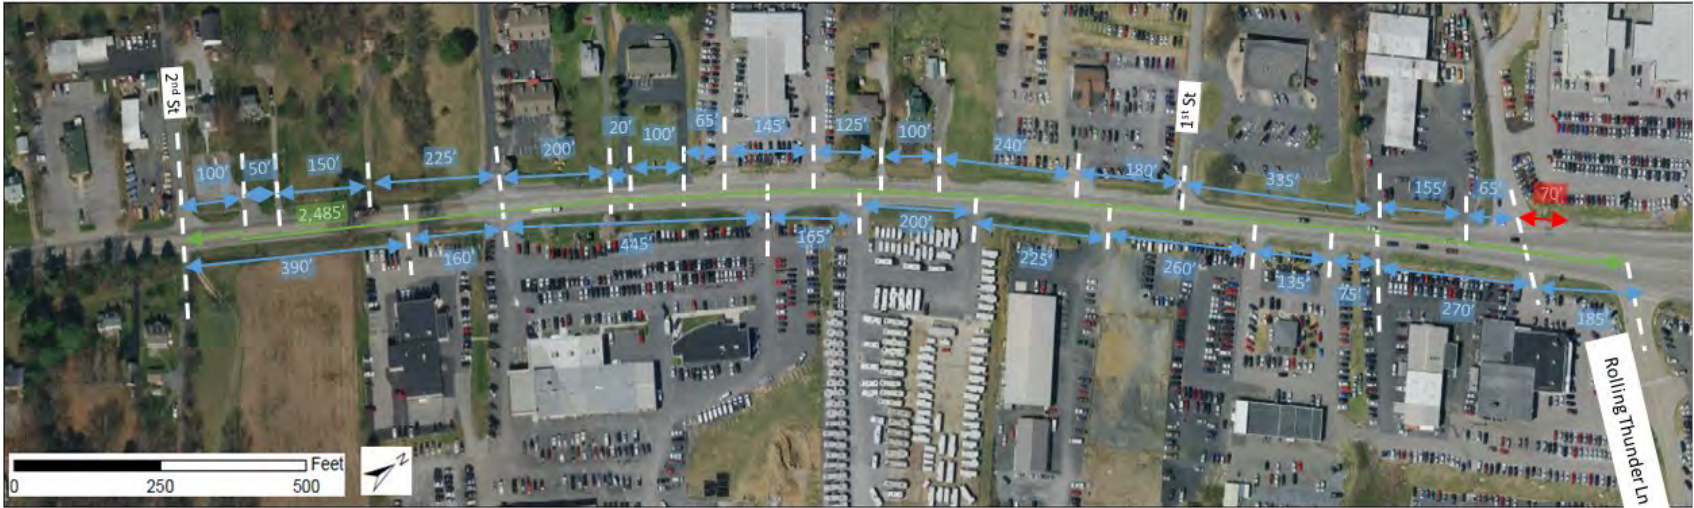
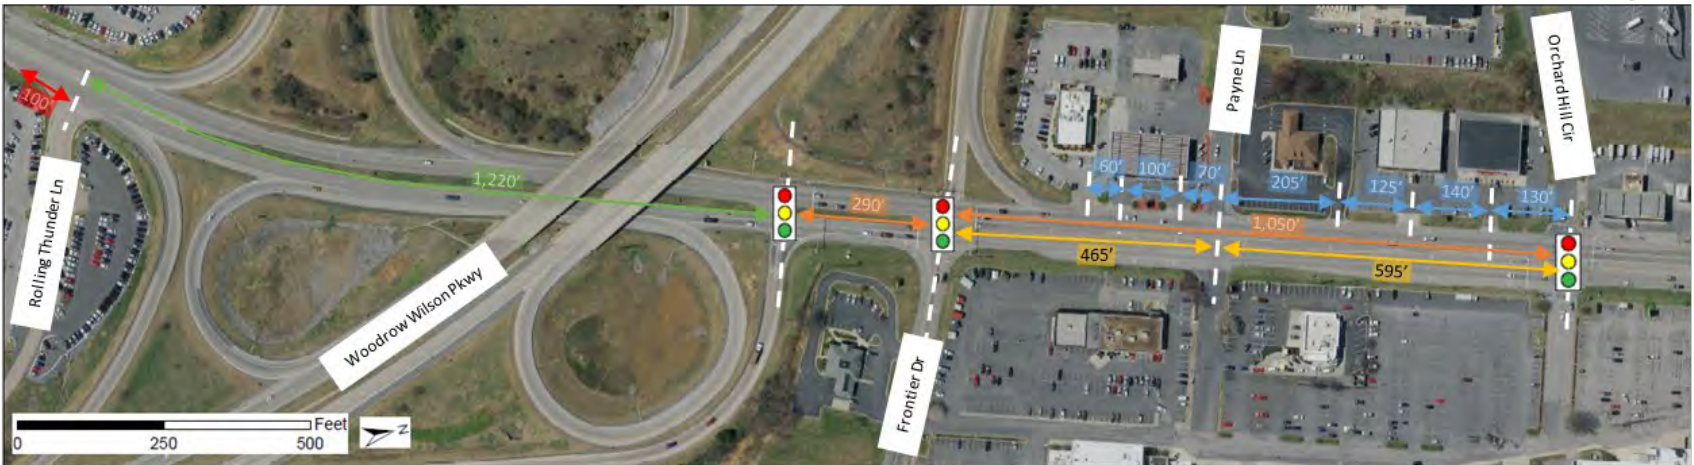
ACCESS SPACING MAP

- **Entrance spacing is deficient along almost entire study corridor**
 - East side spacing generally better than west side (but still not good)
 - Worst areas:
 - Both sides to the south of Route 262 interchange (Auto dealership, DMV office)
 - West side between Orchard Hill Circle and Barterbrook Road
 - Both sides between Campbell St and Statler Blvd
 - West side between Hampton St and Commerce Road
- **Wide swaths of entrances exceed VDOT's maximum entrance widths**
- **High density of entrances complicate turning movements, resulting in angle crashes**

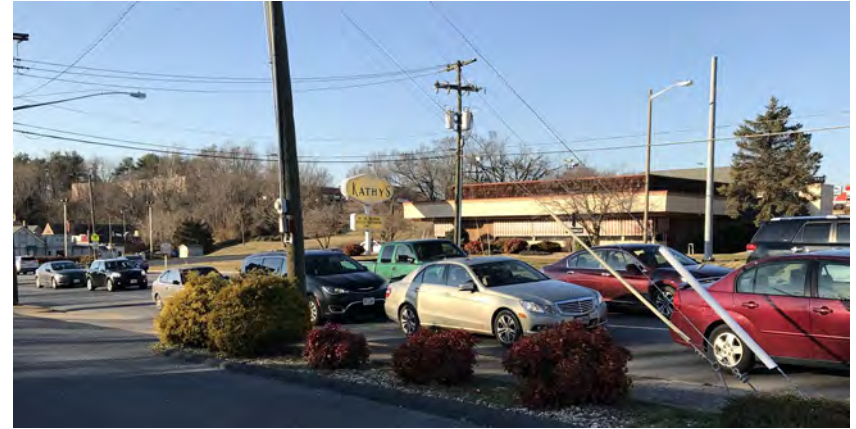
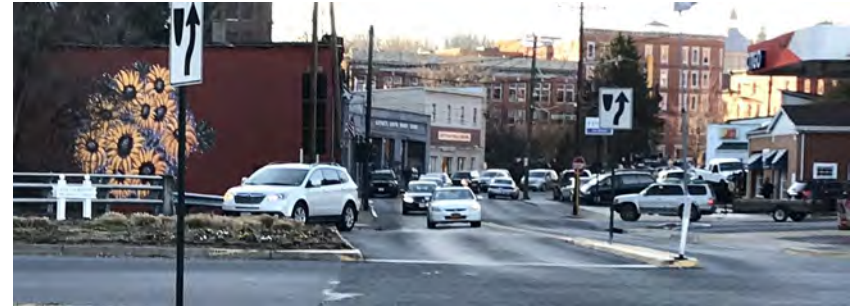
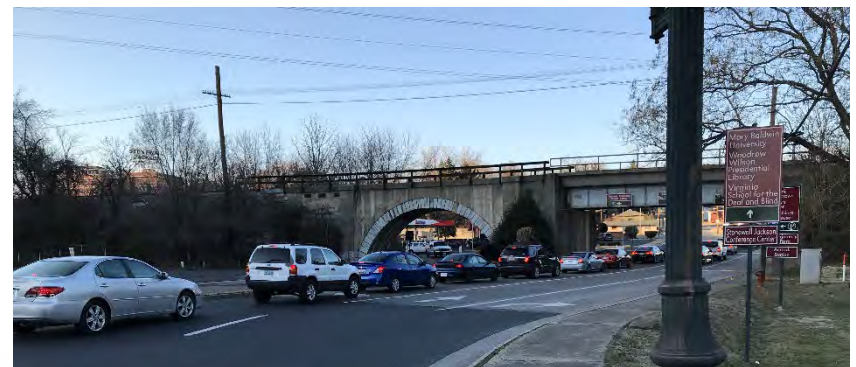
FIELD REVIEW OBSERVATIONS

- Operations generally match Synchro analysis
- PM peak hour has longer queues than the AM peak
- The overall pavement surface and markings are not in good condition
- Significant pedestrian activity was observed throughout the day

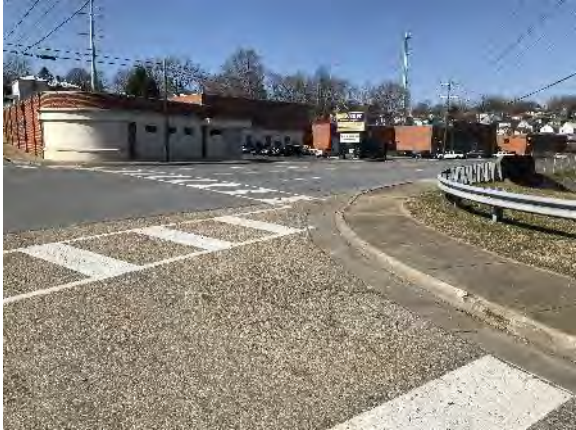
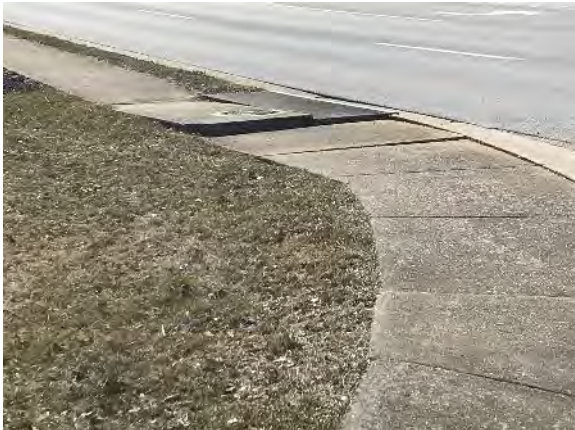
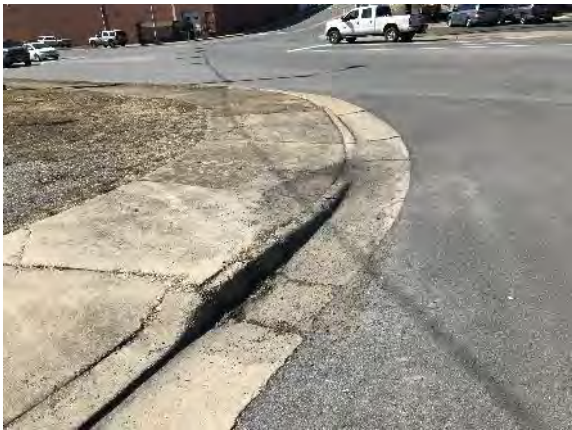
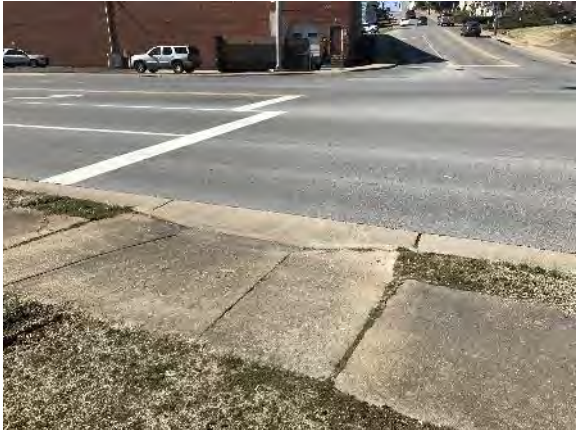
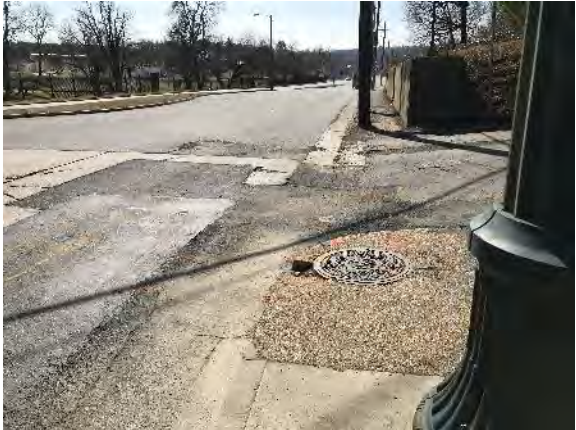
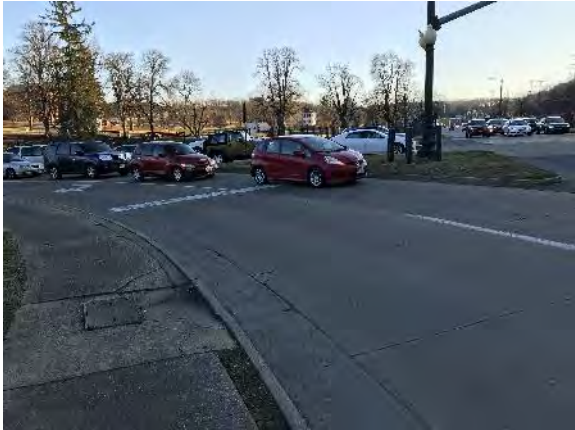
PEDESTRIAN FACILITY CONDITIONS

- **Sidewalk surface is deteriorated and uneven and has debris**
- **Lack of curb ramps connecting sidewalks**
- **Curb ramps, if any, are steep and non-ADA compliant**
- **At several locations sidewalks are encroached by utility poles or hydrants**
- **Lack of pedestrian crossing warning signs in advance of the marked crosswalks**
- **Our field reviewer ran to cross US 11, using the crosswalk on the north side of the Gay Street intersection, to avoid conflicting with vehicles**
- **Lack of pedestrian signals and pedestrian refuge island**

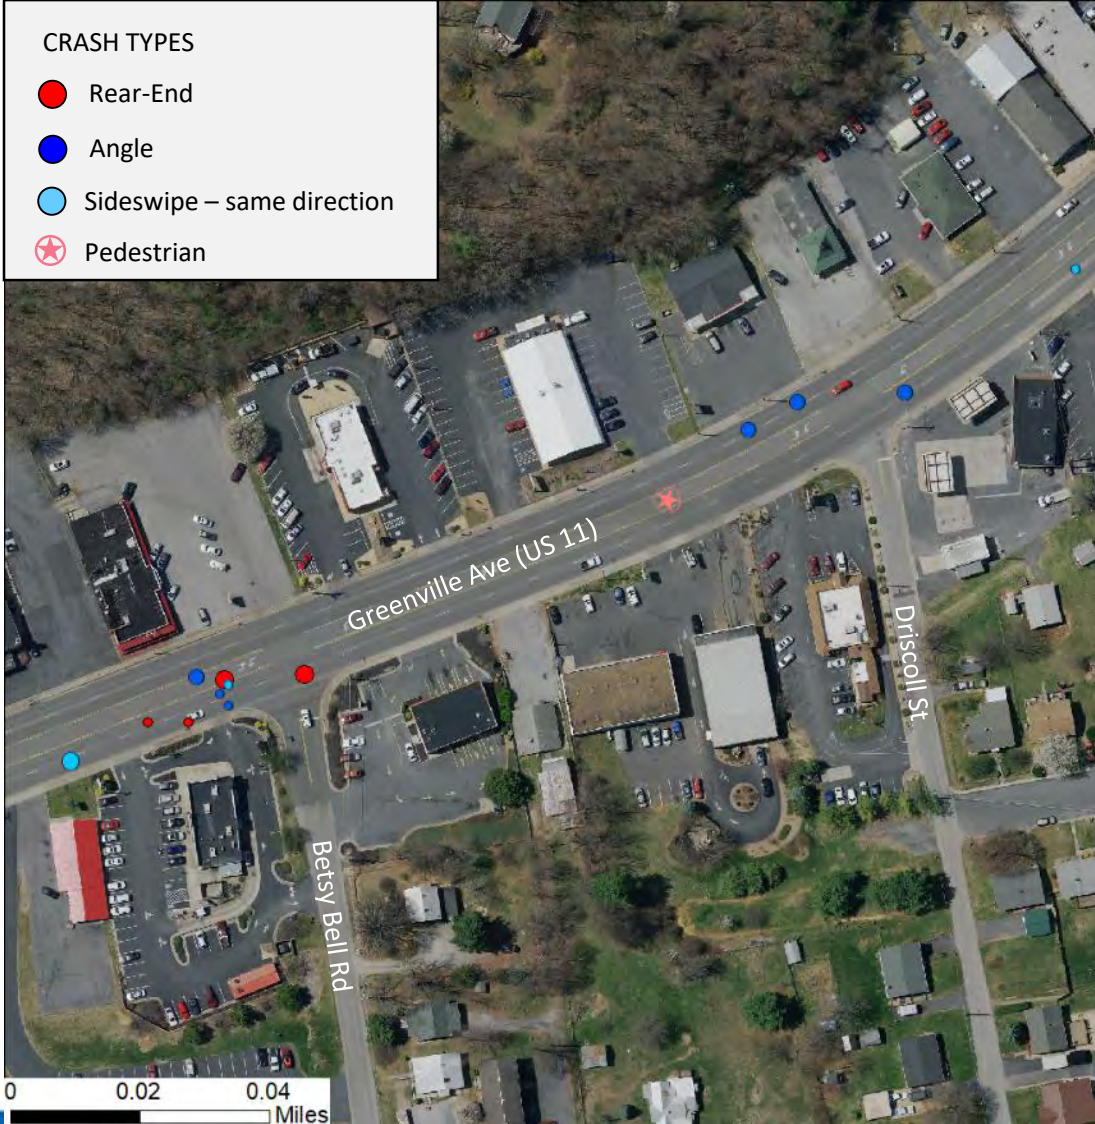
SEGMENT 5: MILEPOST 236.5 TO 236.75

Betsy Bell Rd intersection:

- Cluster of rear-end and angle crashes at Betsy Bell Rd
- Rear-end crashes involved vehicles slowing down at Betsy Bell Rd

Pedestrian Crash:

- One pedestrian injury crash occurred during daylight and under dry surface condition

Potential Causes:

- Several closely spaced entrances on both sides
- Lack of right-turn deceleration lane

Possible Recommendation:

- Install right-turning lanes on both sides
- Consolidate entrances/driveways, provide service road
- Install midblock crosswalk, if warranted

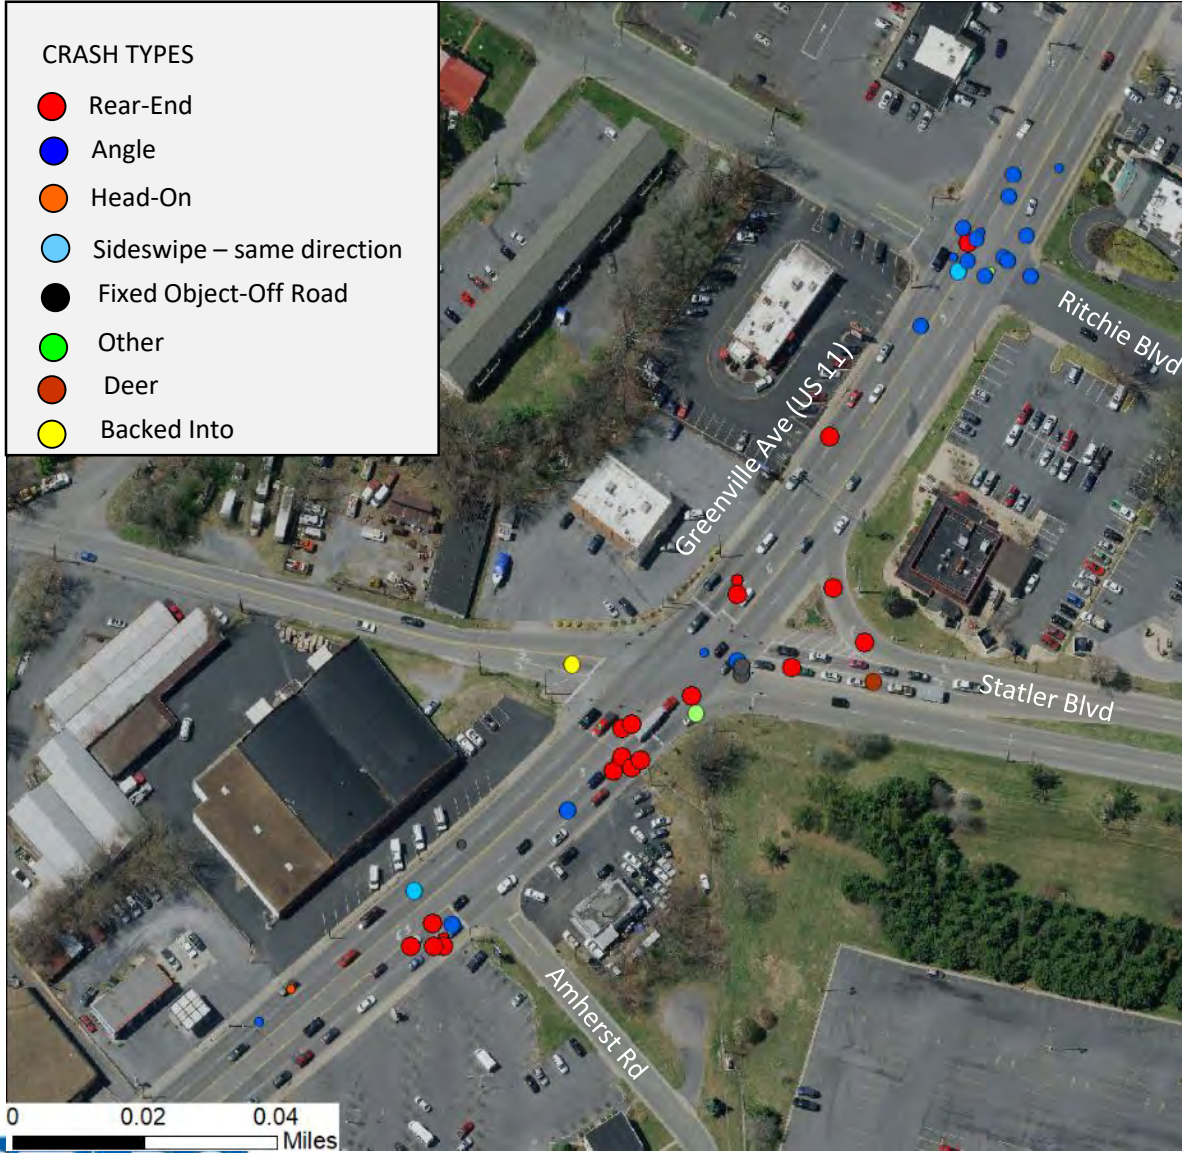
SEGMENT 6: MILEPOST 236.75 TO 237

Ritchie Blvd Intersection:

- Cluster of rear-end crashes.
- Out of 13 angle crashes, 4 involved mainline left-turning and thru vehicles.
- There are several closely spaced driveways to Ritchie Blvd.

Statler Blvd Intersection:

- Cluster of rear-end crashes.
- Heavy NB right-turning traffic

Possible Recommendation:

- Install physically divided median from Statler Blvd to the north of Ritchie Blvd and re-route left turns via Statler Blvd intersection.

- Install “Signal Ahead” warning sign in advance of the intersection.
- Install NBR turn lane.
- Modify lane configuration of the side streets and signal phasing and timings.

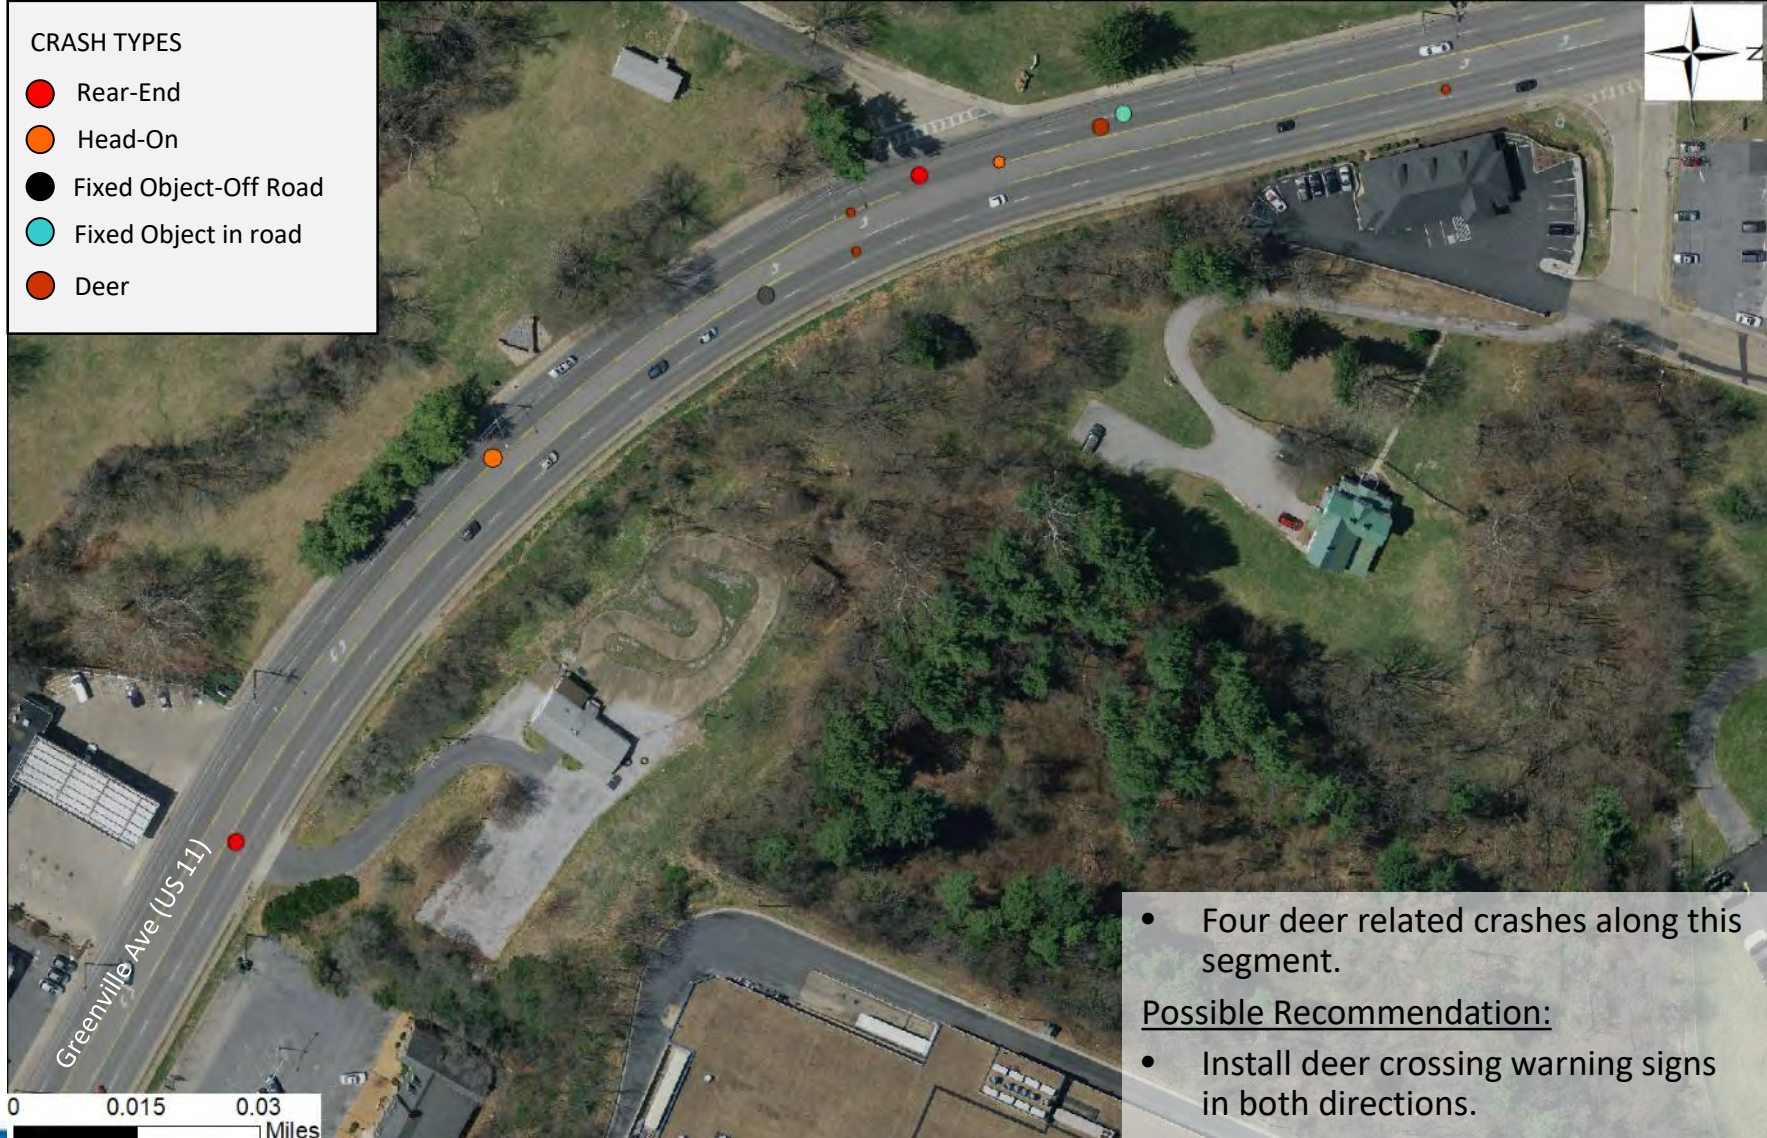
SEGMENT 7: MILEPOST 237 TO 237.25

- Four deer related crashes along this segment.
- Possible Recommendation:
- Install deer crossing warning signs in both directions.

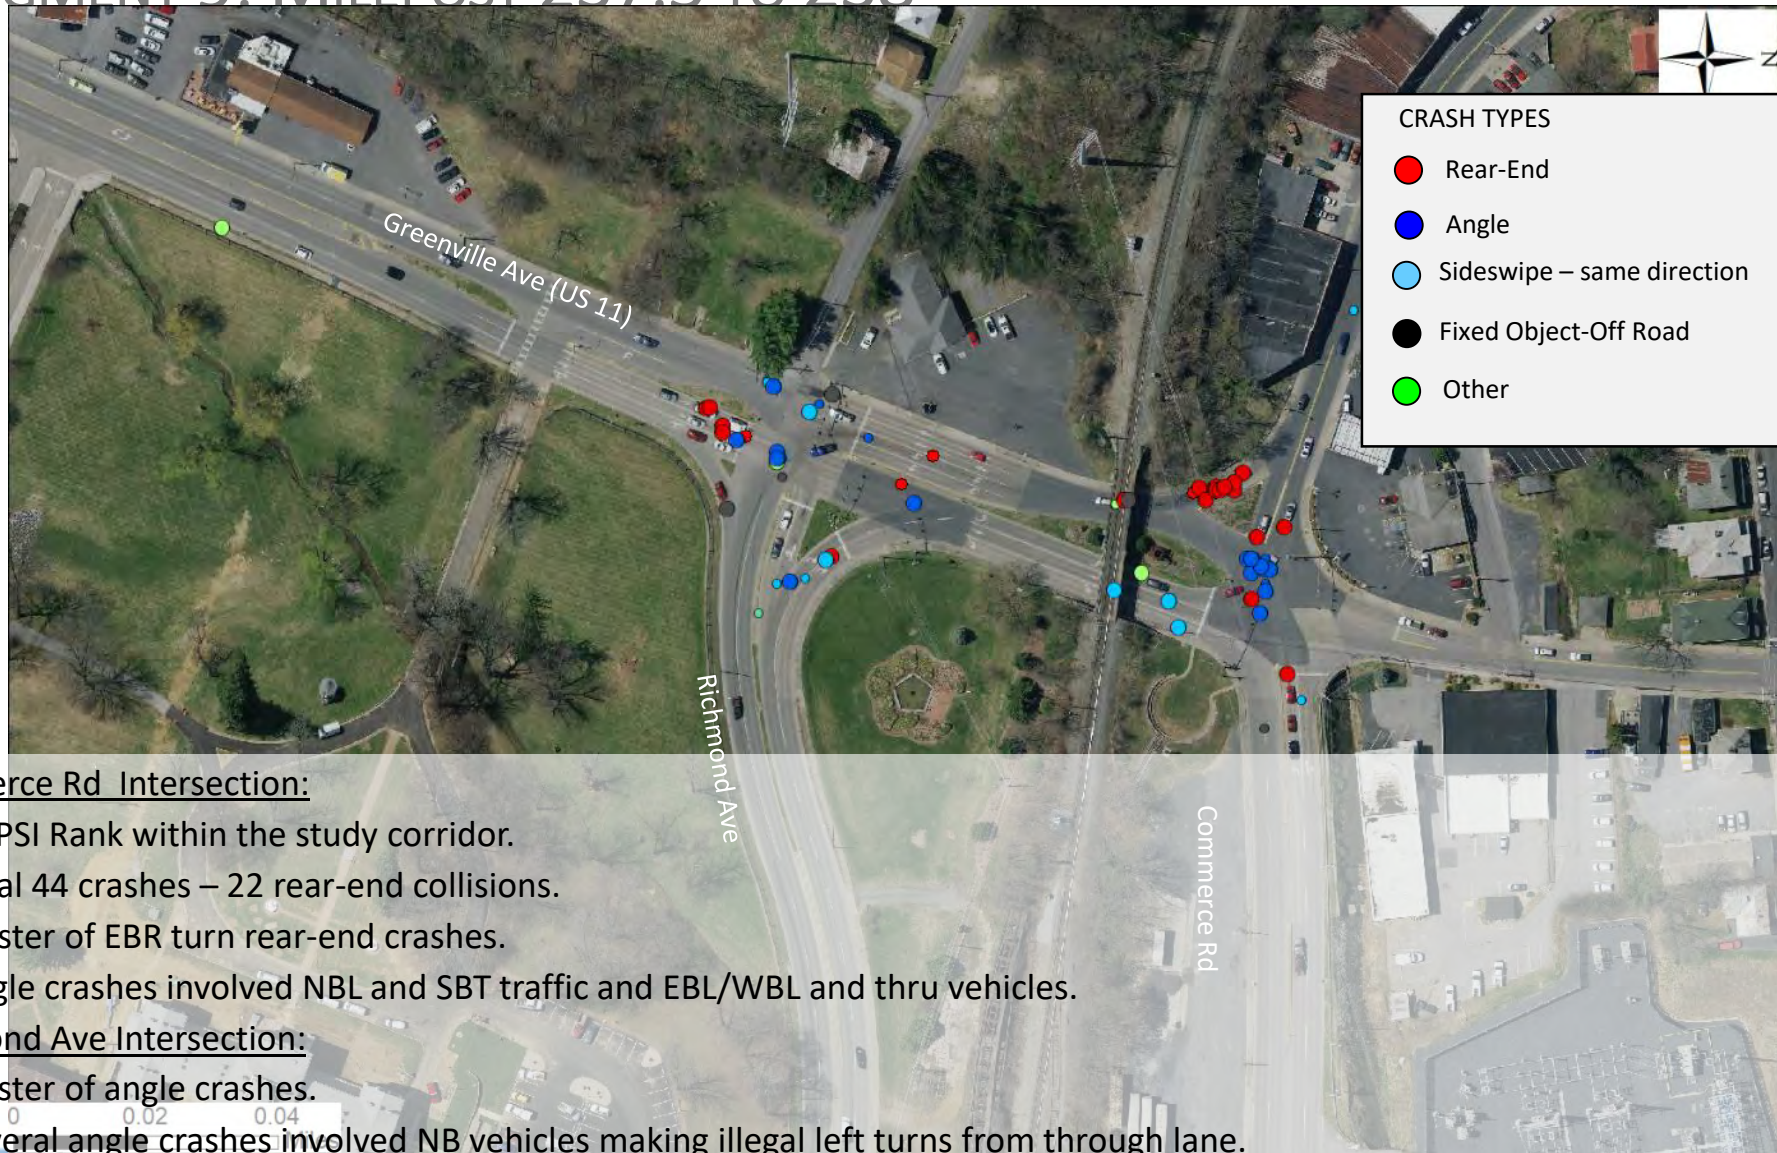
SEGMENT 9: MILEPOST 237.5 TO 238

Commerce Rd Intersection:

- 1st PSI Rank within the study corridor.
- Total 44 crashes – 22 rear-end collisions.
- Cluster of EBR turn rear-end crashes.
- Angle crashes involved NBL and SBT traffic and EBL/WBL and thru vehicles.

Richmond Ave Intersection:

- Cluster of angle crashes.
- Several angle crashes involved NB vehicles making illegal left turns from through lane.

Possible Recommendation:

- Installation of a roundabout at the US 11 at Richmond Ave intersection is expected to reduce angle crashes
- Reconfigure EB Greenville Ave to eliminate left turns and through movements. EBL and EBT turn right and make a U-Turn at the Richmond Ave intersection. Signalize EBR turns.

Long-Term Improvement

- Install a “peanut” roundabout at the intersections of US 11 at Commerce Rd and US 11 at Richmond Avenue

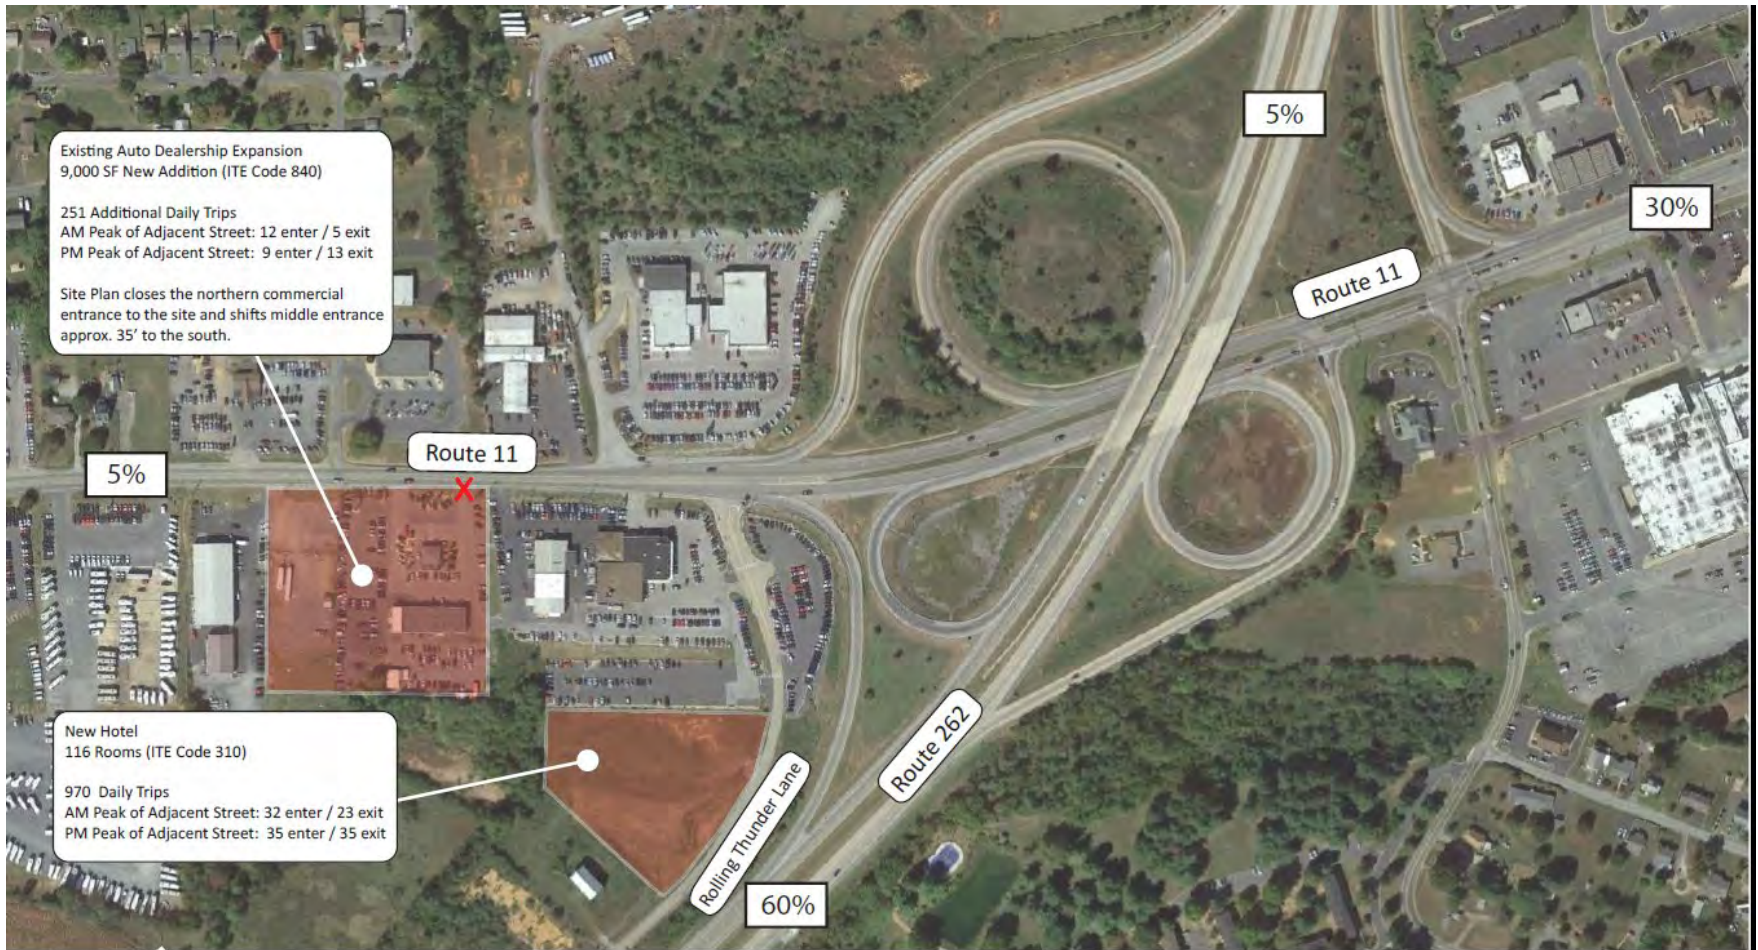
ADDITIONAL TRIPS FROM CORRIDOR DEVELOPMENT

Proposed Corridor Developments Trip Generation and Distribution
 US 11 STARS Study
 Staunton District
